Osseointegration of a displaced dental implant in the maxillary sinus: a 7-year follow-up case report

Citation: Azenha MR, Watanabe PCA, Errázuriz SP, Jardim LF, Sório ALR. Osseointegration of a displaced dental implant in the maxillary sinus: a 7-year follow-up case report. Brazilian Journal of Case Reports. 2025 Jan-Dec;05(1):bjcr3.

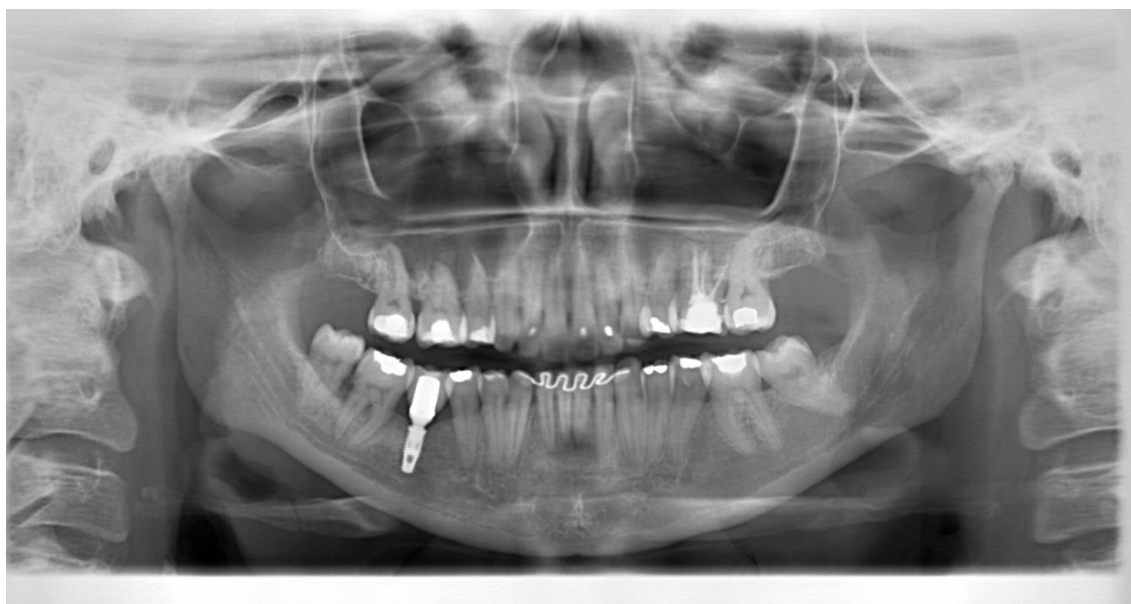
Figure 1. Initial panoramic radiography used to plan upper left first molar extraction.

A 32-year-old healthy woman was referred to our university after upper left first molar fracture with an extensive coronary fracture. Clinical and radiographic exams revealed a longitudinal fracture separating the palatal root from the rest of the tooth and the indication of tooth extraction. A bone height of 7 mm from the cervical of the tooth to the beginning of the maxillary sinus membrane was observed using a panoramic radiography and the surgical planning was to install an external hex implant of 10 mm of length and 3.5 mm of diameter in the center of the alveolus immediately after tooth removal (Figure 1).

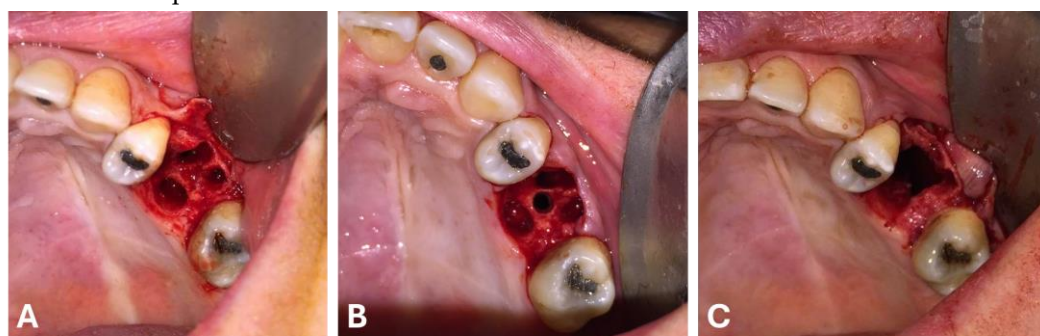
Figure 2. A. Upper left first molar extracted. B. Implant preparation in the center of the alveolous. C. After implant displacement the alveolar bone was removed attempting to recover the implant. Unsuccessful maneuver.

The tooth was uneventfully removed, and the septum bone prepared 7 mm in length to receive the implant at 04/18/2016 (Figure 2A and 2B). At the end of implant installation, it was displaced into the maxillary sinus due to student's lack of experience and poor bone's quality in the region. After several attempts to remove it from alveolar socket (Figure 2c) and due to patient's anxiety condition it was left inside the cavity as seen in the periapical radiography (Figure 3). Patient was medicated with antibiotics, analgesics, and nasal decongestant and oriented to sneeze with the mouth open, no to drink soda beverages and alcohol, to maintain soft diet for the first 5 days and to avoid hot food for the first 48 hours after the surgery. One day after the surgery the patient was evaluated and a computed tomographic (CT) was done demonstrating the exact position of the implant in the posterior region of the maxillary sinus surrounded by blood clot (Figures 4A and 4B).

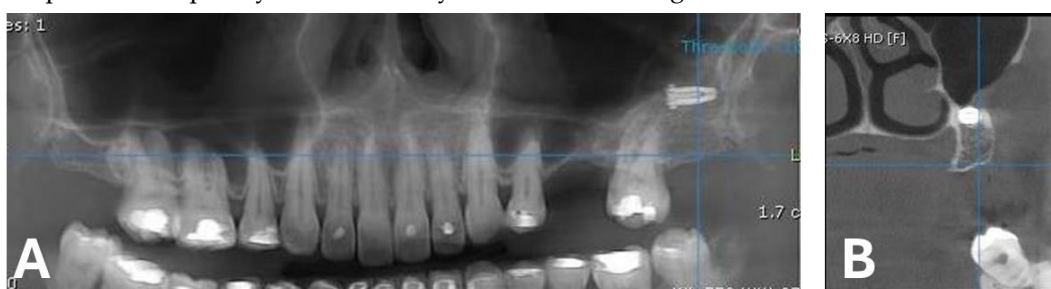
Figure 5. A. Computed tomographic image 24 months after implant's displacement. B. Computed tomographic image (coronal view) 24 months after implant's displacement. Implant is completely surrounded by bone and osseointegrated.

The patient decided not to do the surgery and didn't return to our clinic until 06/25/2018 when we did a new TC exam that revealed the implant was surrounded by bone suggesting it was osseointegrated (Figures 5A and 5B). Maxillary sinus was healthy with no signs of infection. Patient was again evaluated after 36 months of the surgery and a panoramic radiography confirmed the same findings as previous TC exams (Figure 6). The last TC exam was done in 04/12/2023 (7 years after the surgery) and it was conclusive to demonstrate the dental implant is osseointegrated and located at the same position as in the first TC surrounded and filled by mature bone with no evidence of local infection neither any complain from the patient (Figures 7A to 7C). The excellent images of the 3D TC were vital to our conclusion. This must be the first and only reported case of a dental implant totally osseointegrated inside the maxillary sinus surrounded and filled by bone with no sign of sinus infection. Patient still under control every year and was instructed to seek assistance when needed.

location of a lost implant [7,10]. As described before, patient didn't agree to remove the implant after its displacement and CT exam and was discharged with antibiotics and nasal decongestants. Respecting her decision, we kept her under surveillance and for our surprise the 24-month follow-up CT exam revealed an asymptomatic patient with no signs of sinusitis and an interesting image suggesting the implant had osseointegrated inside the maxillary sinus. Similar results were observed after 36 and 84-months follow-up image exams.

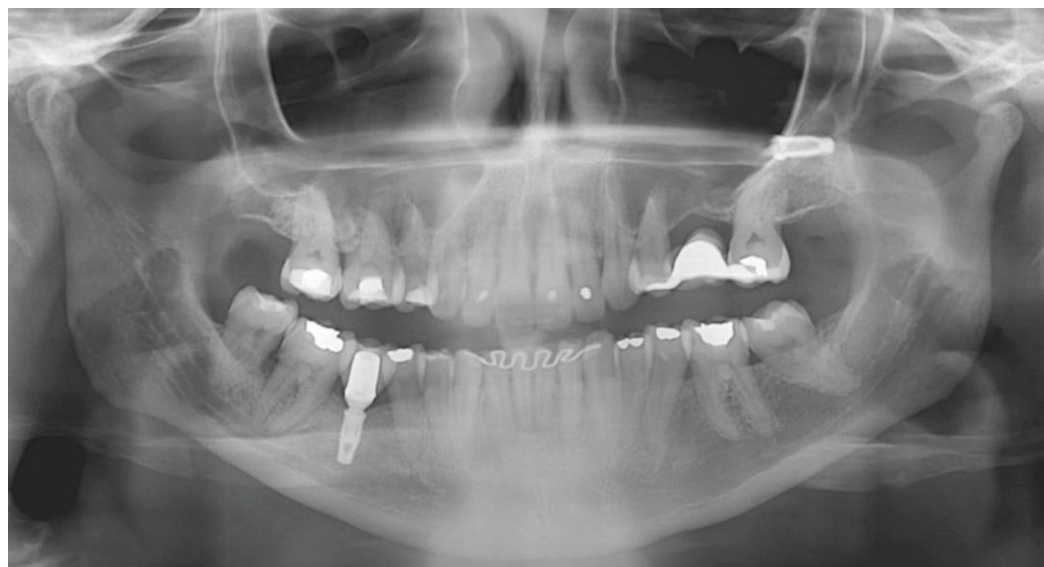
Figure 6. Panoramic view 36 months after implant displacement. No signs of sinus infection and implant still osseointegrated.

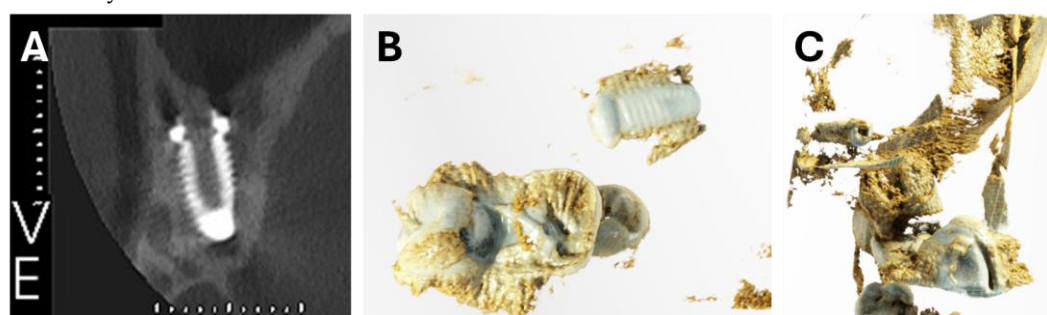
Figure 7. A. Implant completely surrounded and filled by bone and no signs of infection 7 years after its displacement. B. 3D CT reconstruction of the implant that is covered by bone inside the maxillary sinus. C. Bone surrounding the implant that is located inside the maxillary sinus.

The biological principles of osseointegration have already been described and is defined as the direct and structural connection between living and structured bone, and the surface of an implant subjected to a functional load. A dental implant for osseointegration needs to be and remains stable for at least a few weeks [11]. What might have occurred in this case is that when the implant was displaced into maxillary sinus it may have become stuck and stabilized in the bone tissue of the posterior region of the maxillary sinus and the formation of a clot occurred and helped to maintain the implant at the same position. After a few days, there was healing in the region of the rupture of the membrane and the replacement of the clot by new bone tissue in contact with the implant. This is a rare and unique case of a dental implant that has osseointegrated inside the maxillary sinus and

still without symptoms after 7 years of its displacement. The real challenge of this case is to be aware of any sign of sinus inflammation and be ready to remove the implant if indicated, being surgical planning essential to minimize the risks of this complication.
